Wieland-Werke AG 89070 Ulm Germany

11.09.2015

Examination of copper plumbing tubes

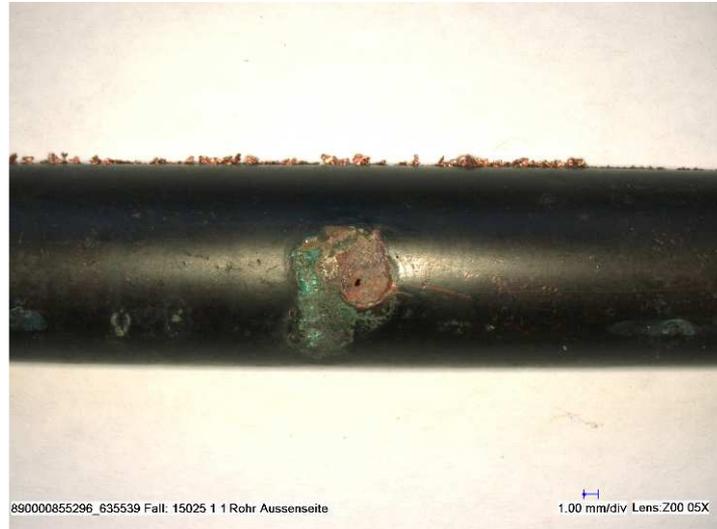
External surface:

The external surface of the samples is showing a thick dark-brown oxide layer and several areas with severe, locally concentrated corrosion attack.

The penetration started on the outside surface of the tube and penetrated the whole wall.

If installed in areas with aggressive atmosphere or together with building products that may contain aggressive substances we would recommend to use coated copper tube to prevent such type of damage. This is especially important when installed in floors or ceilings.

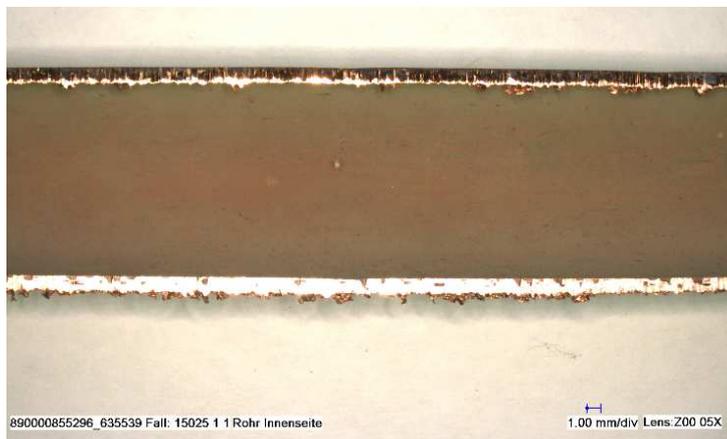
Internal surface:

The inside of the tube is showing a regular, homogenous dark brown coloured surface. The internal surface is undamaged and corresponds to the natural oxide layer being formed during use.

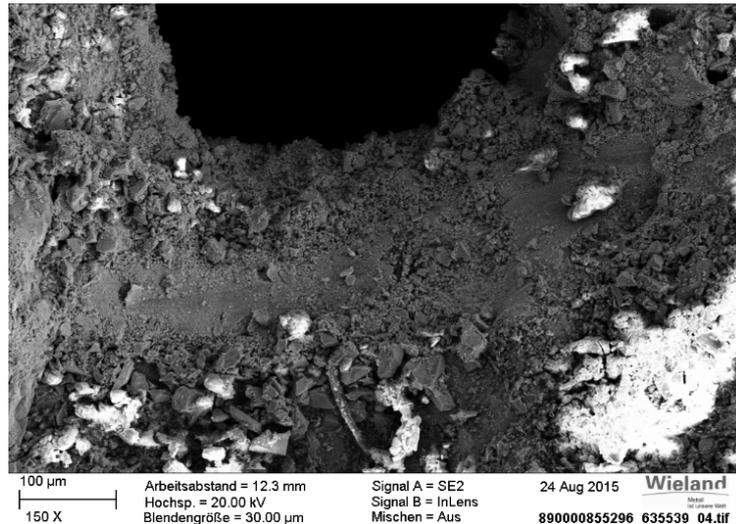
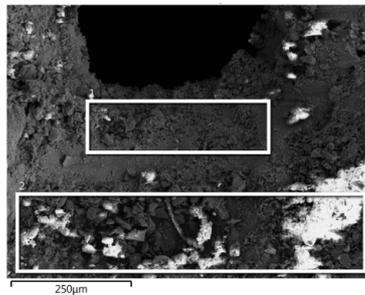
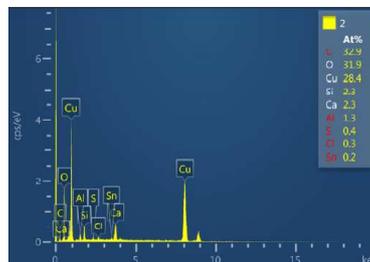
According to scientific literature, such a phenomenon has to be classified as external corrosion. The areas with severe corrosion attack were examined as well by means of SEM to trace back elements on the surface:

Due to the absence of sufficient quantities of corrosion products on the outside surface, it was not possible to trace back additional information about chemical influences or the trigger for the external corrosion.
